## **ANALYSIS OF FACTORS CAUSING FLOODING IN PEOHO VILLAGE, WATUBANGGA DISTRICT, KOLAKA REGENCY**

ISSN: 2716-4837  
Vol. 7, No. 1, June 2025  
URL: <http://usnsj.id/index.php/geographica>

*This study aims to analyze the factors causing flooding in Peoho Village, Watubangga District, Kolaka Regency. The type of research used in this study is descriptive research with qualitative and quantitative approaches. The data used in this study consists of rainfall data, soil type, slope gradient, land use, drainage system, flood control buildings and river conditions in Peoho Village. The data were collected using various methods including observation techniques, interviews, and documentation. Qualitative data were analyzed using qualitative data analysis according to Creswell. While quantitative data were analyzed using descriptive statistics. Based on the results of the study, the factors causing flooding in Peoho Village, Watubangga District, Kolaka Regency were caused by various factors, including moderate to high rainfall intensity. Another factor that causes flooding is the type of chromic latosol soil. This type of soil has a clay texture and small pores so that it quickly becomes s

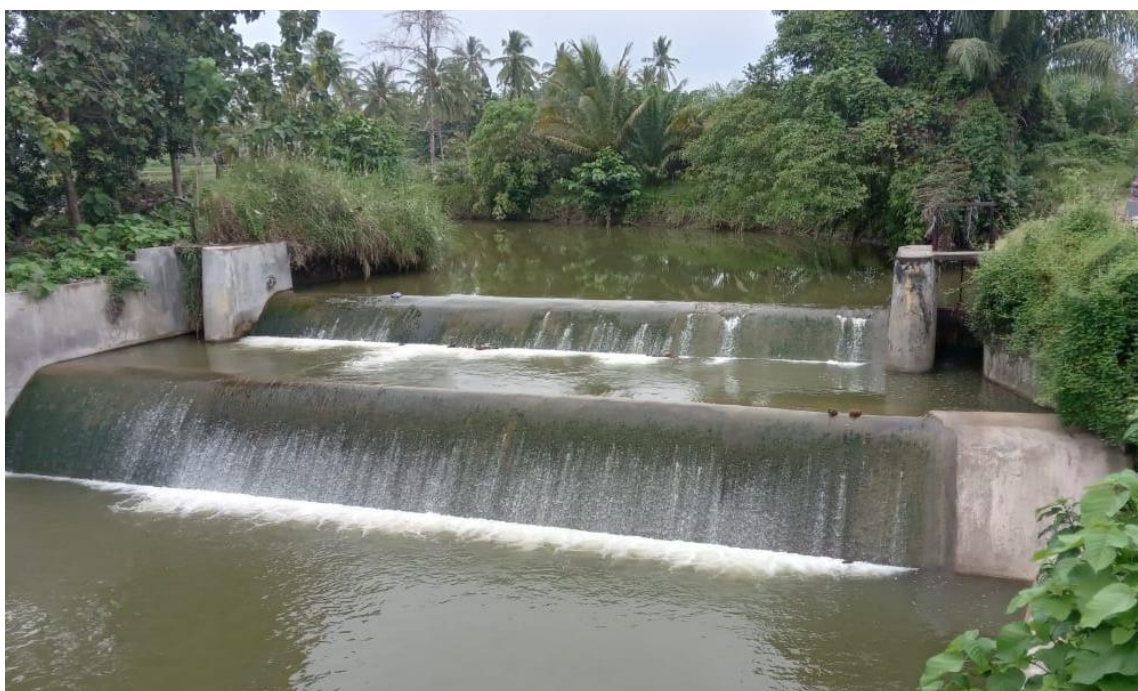
**Figure 5.** The Dam of Peoho Village, Watubangga District

Flood control structures are structures designed to reduce the impact of flooding, either by controlling the flow of water or by containing it. Based on the research results, the flood control structure in Peoho Village is a dam. The dam functions to contain water and release it in a controlled manner, so that it can reduce the volume of flooding downstream. In addition, the community uses the dam to irrigate rice fields. The dam in Peoho Village functions well in controlling flooding. However, when the rainfall intensity is high, the dam is unable to accommodate the water. As a result, the air will overflow and cause flooding. This condition is caused because the dam in Peoho Village has a relatively small capacity. The condition of the dam in Peoho Village, Watubangga District, Kolaka Regency is presented in the following figure.

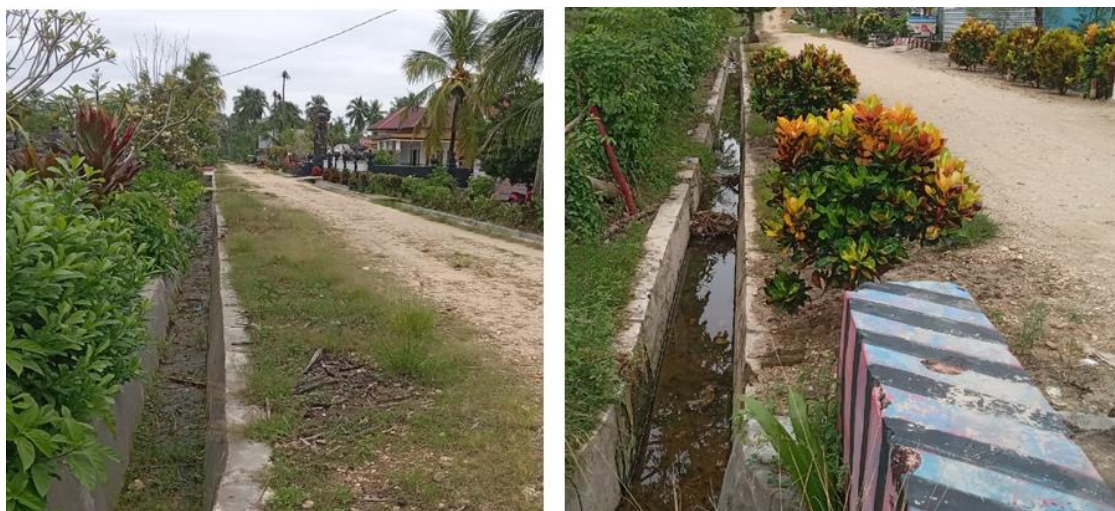
**Figure 6.** *The Drainage System of Peoho Village, Watubangga District*

Based on the research results, Peoho Village has a drainage system as shown in the figure 6. Peoho Village has drainage channels on several roads. However, these channels do not function to drain water, they only collect the water. As a result, if there is heavy rain, the water collected in the channels will overflow and inundate the surrounding areas.

Based on the results and discussion, it can be concluded that flooding in Peoho Village, Watubangga District, Kolaka Regency is caused by several factors, namely rainfall, slope, soil type, land use and a drainage system that is not functioning properly. The higher the intensity of rainfall can cause the higher the potential for flooding. The potential for flooding will be even higher if the soil conditions are unable to drain water into the soil because it has a clay texture with small pores such as the type of latosol chromic soil in Peoho Village. If water is unable to seep into the soil, it will increase surface flow. Surface flow will be higher if vegetation on the surface of the soil is also reduced. This condition will cause the river body to fill up faster and can overflow into a flood. Likewise, the drainage system will accelerate flooding if it does not function properly to drain water.

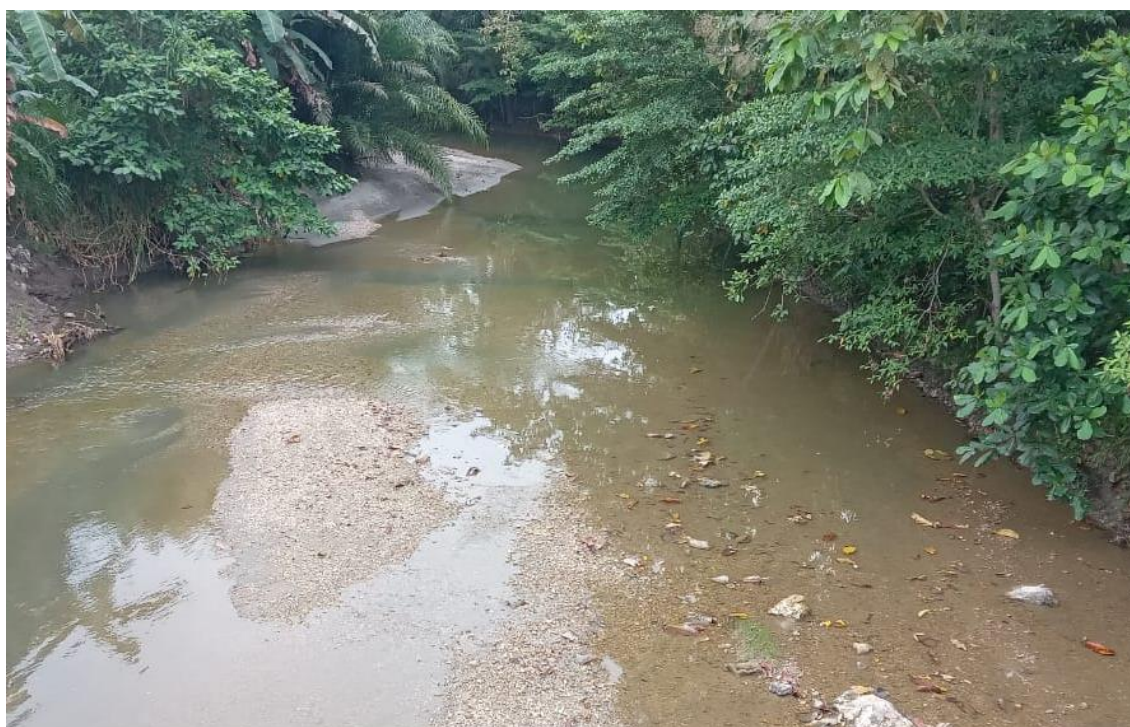
**Figure 7.** *The River Condition in of Peoho Village, Watubangga District*

Based on the research results, the condition of the river in Peoho Village is very good. The river body looks clean from garbage or vegetation and there is no narrowing. Although there is sedimentation, the flow of water in the river also looks smooth without obstacles. The condition of the river in Peoho Village, Watubangga District is presented in Figure 7.
